CASE HISTORY

ECP STEEL PIERS™ STANDARD MODEL 350

Dixie National
Forest Service Office,
Cedar City, UT

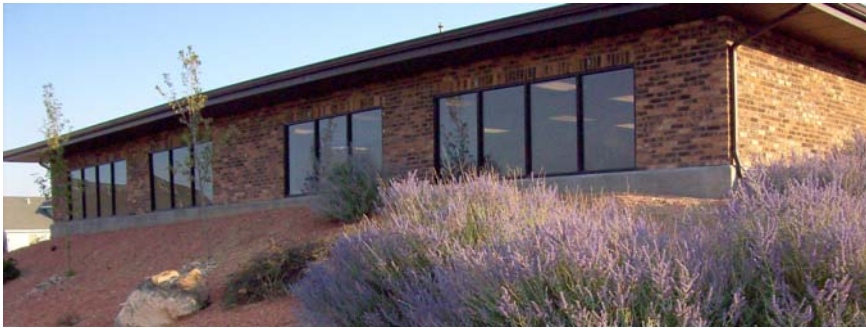
Photographs: At the top is a view of the settled structure showing the large depth of fill below the foundation. At top right the excavations are prepared at pier locations along the perimeter of the structure. Above right shows how the foundation was prepared for mounting the pier bracket. The technician is smoothing the face of the stem wall. The bearing area under the footing was also similarly prepared. At right a technician installs one of the drive stands that were used to advance the pier pipe through the soil to end bearing.

Earth Contact Products' Steel Piers™ were selected to support and restore this office building after the owner determined that the entire structure had settled between 1/8 inch and 3-5/8 inches. The settlement was most likely caused by consolidation of fill soil on the lot. Merit Structures and Restoration Company from Midvale, Utah installed ninety seven ECP Model 350 Steel Pier™ systems to recover lost elevations.
